# CONCERNED NEIGHBOURS AND CYCLISTS FOR UNION STREET BIKE PATH SAFETY

RTS No. 02089

TO: Standing Committee on Transportation and Traffic  
FROM: General Manager of Engineering Services  
SUBJECT: Zebra Pavement Markings and Wider Crosswalks

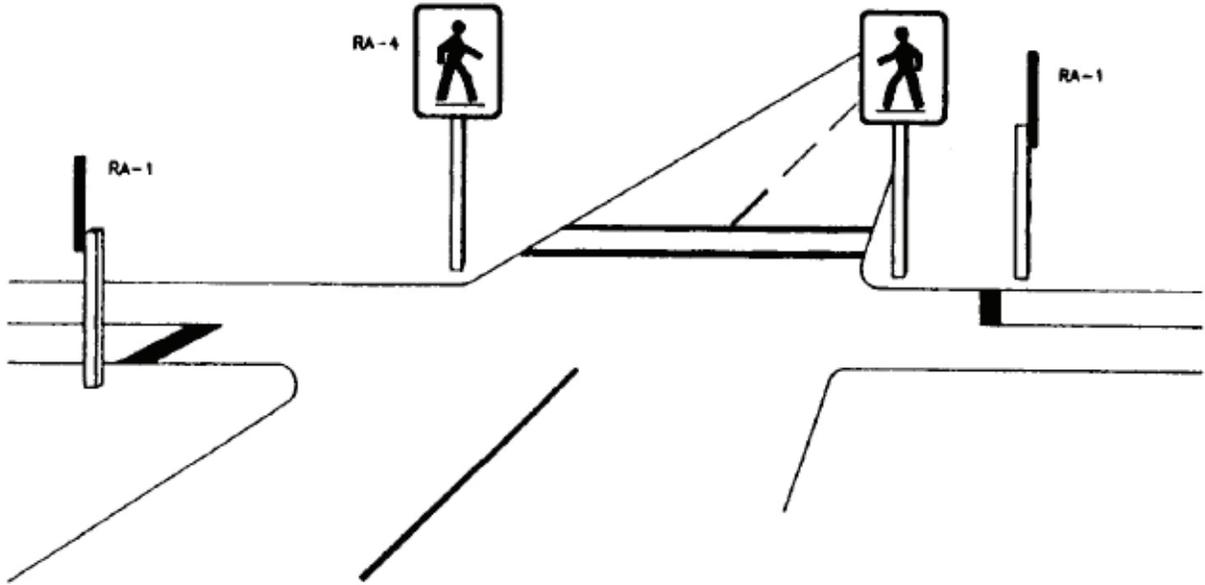
**Figure 1** - Pedestrian Crosswalk with Twin Parallel Lines

The minimum standard for a marked crosswalk consists of ground mounted signs and pavement markings, as displayed in Appendix A. Where required, overhead and advanced warning signs are used. For crossings that are associated with a school route, school crosswalk signs would be used at the crossing. There are currently two designs of pavement markings recommended in the Pedestrian Crossing Control Manual, namely the standard crosswalk with twin parallel lines, and zebra markings. Zebra pavement markings have not been used in Vancouver and it is recommended that they be introduced because of the increased visibility of the design.

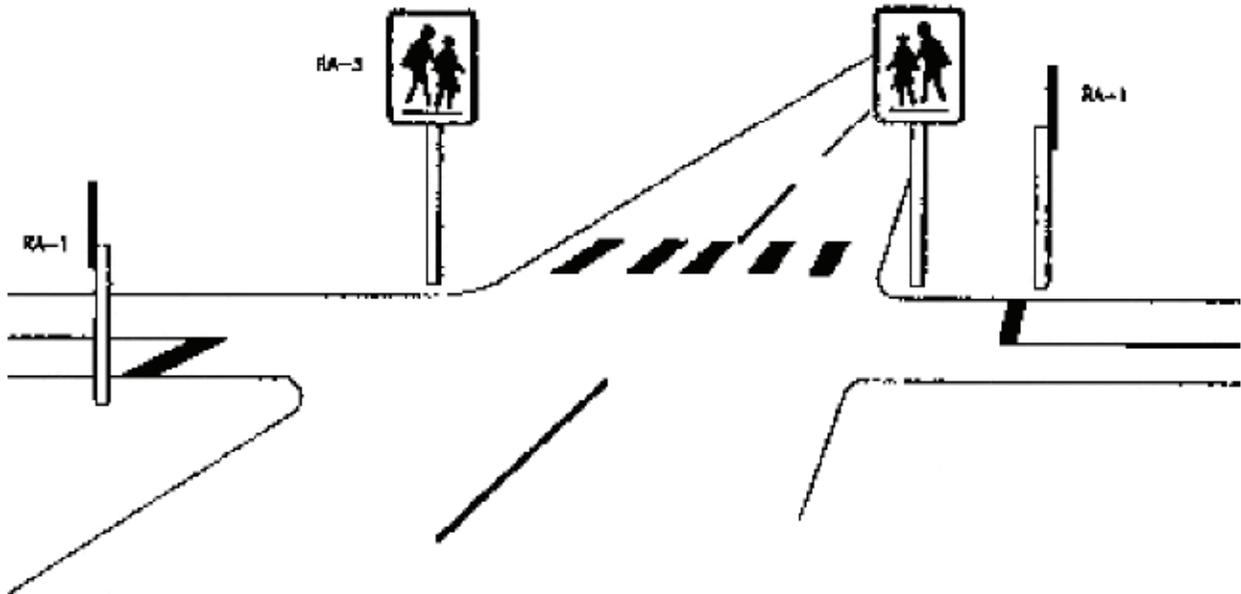
**Figure 2** - School Crosswalk with Zebra Pavement Markings and Advanced Warning Sign

The zebra pavement marking is an alternative recommended for special circumstances. These circumstances include crossings involving school children, the elderly or disabled, mid-block crossings, pedestrian crossings of right turn channels, and Special Crosswalks.
